POST-GLASS BREAKAGE PERFORMANCE OF LAMINATED SAFETY GLASS

INTRODUCTION

This bulletin therefore outlines the various tests that are used to analyze the impact resistance and post-glass breakage performance of laminated glass.

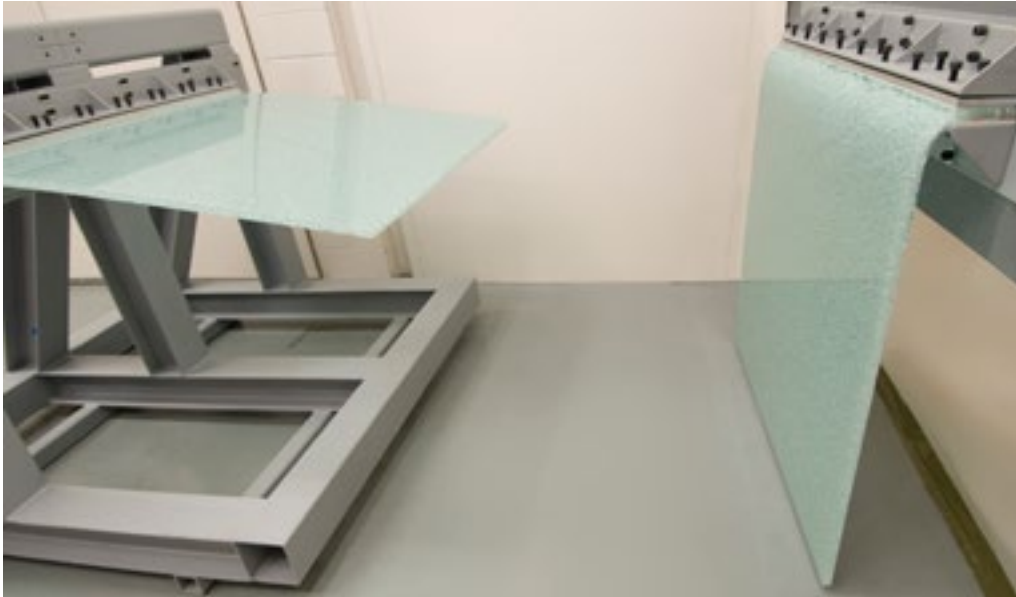
SentryGlas® vs PVB -
post-glass breakage

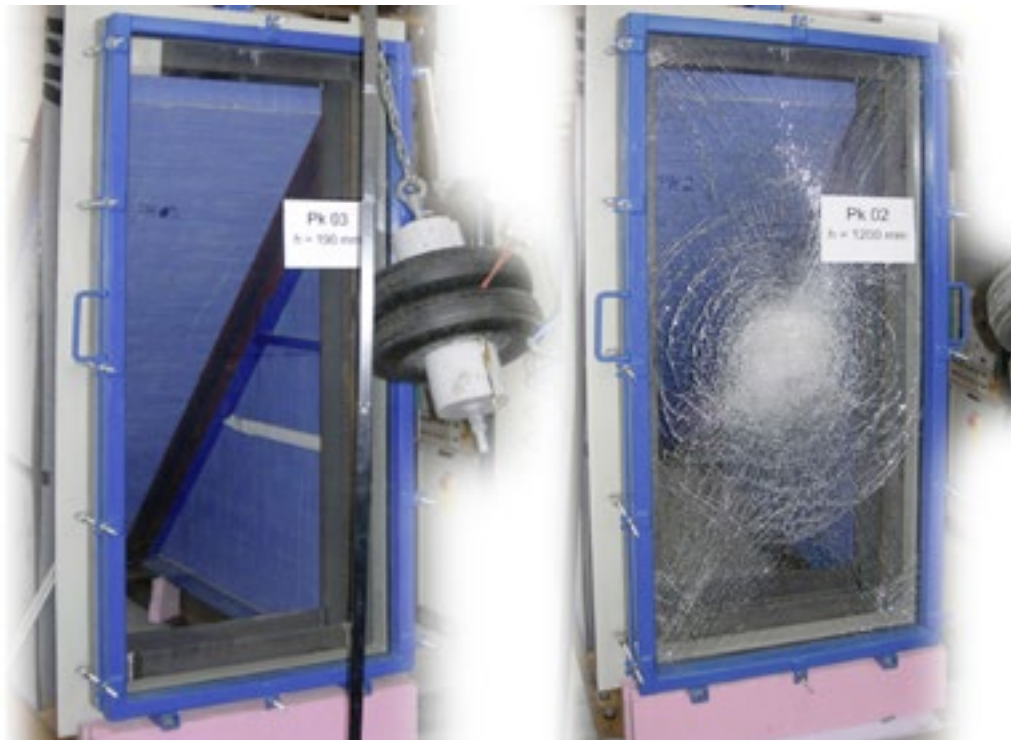
IMPACT TEST

In terms of impact resistance, the benefits of SentryGlas® ionoplast interlayer compared to PVB are shown in the figure below.

Impact test EN 12600 by University of Applied Science, Munich, Germany, 2009.

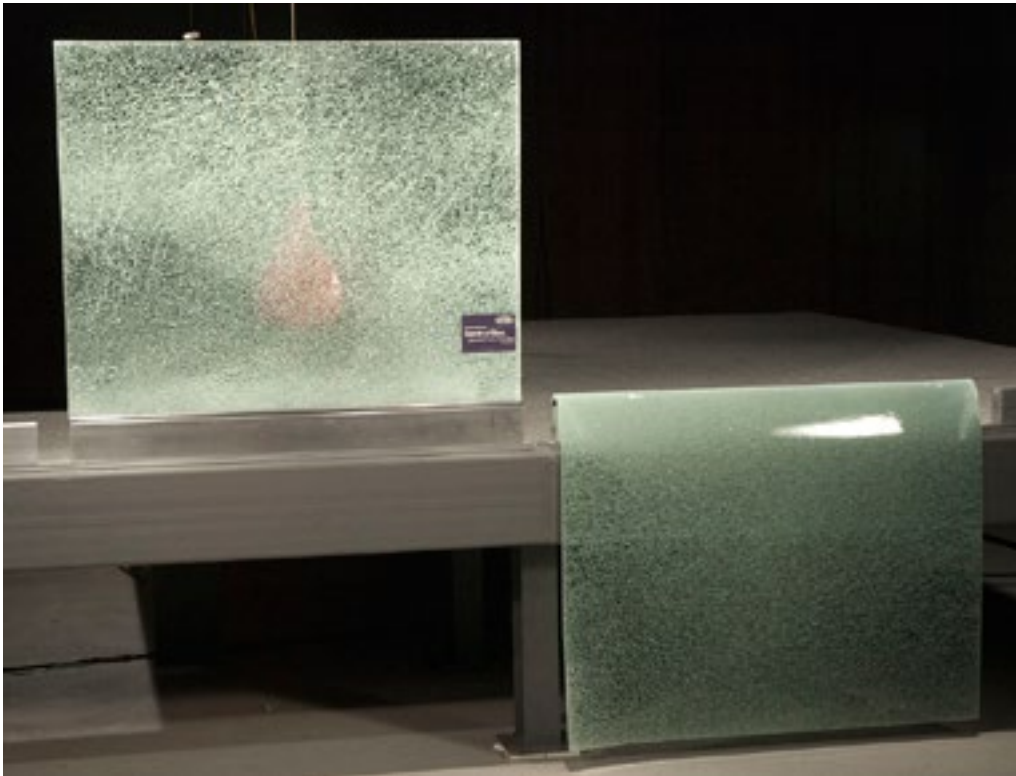
COMPARATIVE TESTS ON BALUSTRADES WITH PVB AND LAMINATES WITH SENTRYGLAS®

In further tests at Kuraray, cantilevered glass balustrades / railings were tested for their post-glass breakage performance. These impact tests simulate potential human loading. The tests involved multiple high

strength glass types (all were fully tempered with open, polished edges). This included laminates with PVB interlayer, SentryGlas® interlayers, monolithic fully tempered glass, and applied PET film.

The tests involved the use of cantilevered glass balustrades manufactured by R.B. Wagner Industries, which were impact tested

using a 45 kg (100 lb) shot bag dropped from various heights.

The multiple glass panels were all mounted into a channel using a dry-glazed mount-

ing system. The shot bag was dropped from 1.524 m (5 ft) (500 ft.lbs of energy).

- The test results showed that the laminates with SentryGlas® interlayer provided significant increased post-breakage strength compared to the laminate with PVB interlayer.
- Fully tempered monolithic glass provides no residual barrier on impact breakage.
- Applied PET film does not retain the glass in place on breakage.
- PVB laminates remain attached to the system on impact breakage. However, PVB laminates display no residual barrier after glass breakage.
- Laminates with SentryGlas® do display a residual barrier after glass breakage. The 0.89 mm (35 mil) SentryGlas® demonstrates considerable post-glass breakage integrity. The 1.52 mm (60 mil) SentryGlas® allows a reduction in glass thickness, with good barrier performance.

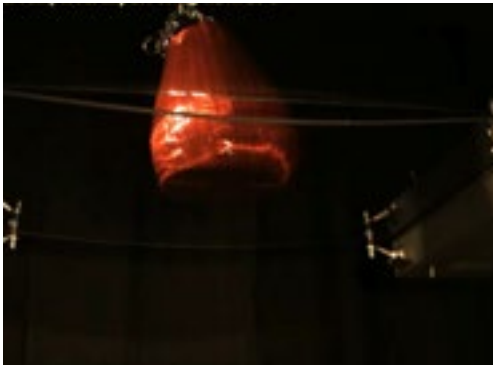
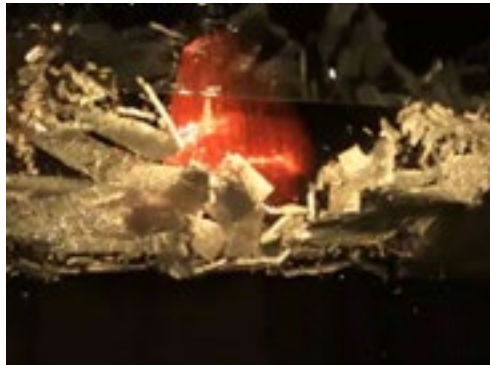
TEST TEMPERED GLASS

canopy test / tempered glass / 50 kg (110 lb)

- From these tests, it was concluded that tempered glass provides no barrier to fall-through after the glass is broken at room temperature and elevated temperatures.
- In the 23 °C (73.4 °F) test, standard PVB laminates survives the initial impact, but fails after 15 seconds, providing no barrier to fall-through after the glass is broken.
- At 50 °C (122 °F), standard PVB laminates, stiff PVB laminates and EVA laminates all failed immediately on impact, providing no barrier to fall-through after breakage.
- At both 23 °C (73.4 °F) and 50 °C (122 °F), laminates with SentryGlas® provides impact resistance and remains in place after glass breakage for the test conditions used (and therefore provides a barrier to fall-through).
